GM OIL FILTER PG5839 / PG5839EX INSTALLATION PROCEDURE

2017 - 2018 COLORADO/CANYON - 3.6L

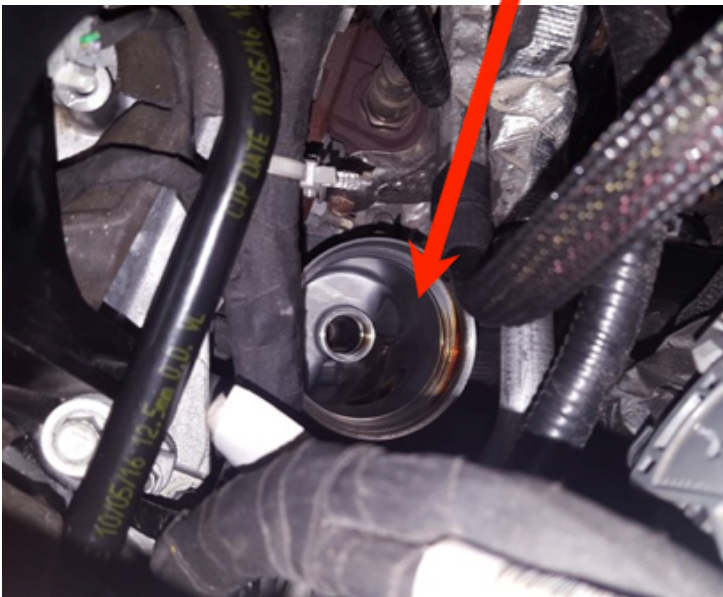
These filters will require attention when being installed in a 2017/2018 Colorado/Canyon equipped with 3.6L. There is a potential service problem that may happen when performing an oil change on these vehicles. During the replacement of the oil filter, please be aware that the oil filter insert (center tube) is still in it's original position in the oil filter adapter/housing. This insert could become detached from the adapter and lodged inside the filter, causing it to be thrown away by accident.

Housing **Missing** Insert

If the insert is missing, then critical engine failure can occur.

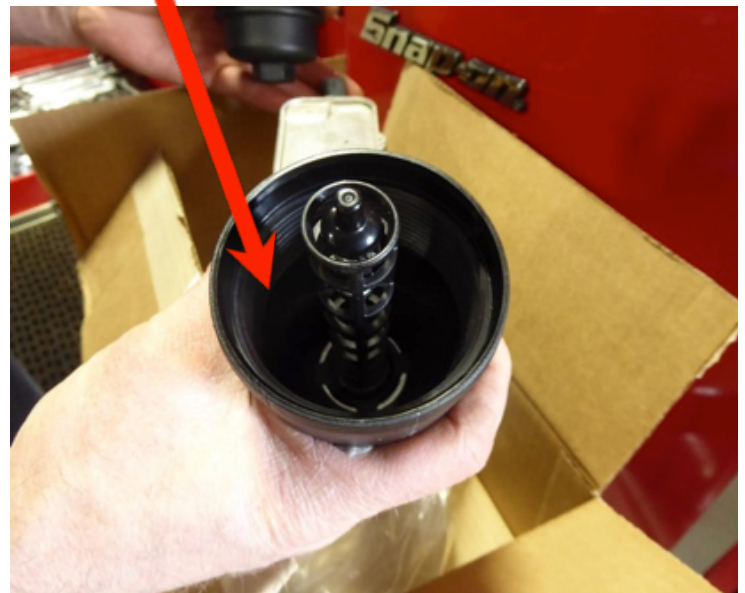
Housing **With** Insert
